### **Kilton Cottage, Verandah Restoration – Project description**

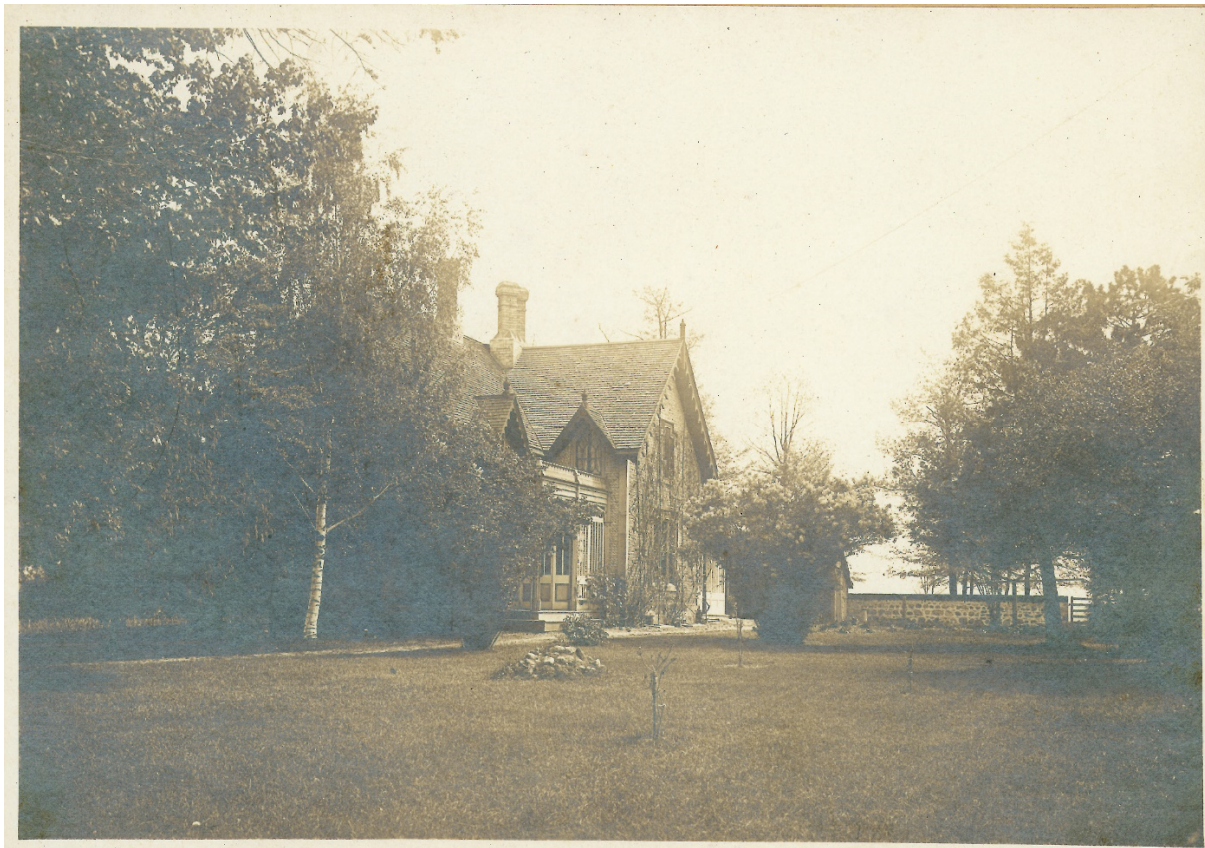
The original verandah was, to the best of our knowledge, constructed with the house in circa 1857, by owners David and Matilda Patton. It is expected that the original structure would have been some type of timber structure with mortise and tenon joints. This structure, as can be seen in the only known photograph of it (below), was highly decorative and an excellent example of gothic revival domestic architecture.

The restoration design for the verandah has been developed over many years while juggling other family and work responsibilities. The decoration, dimensions and structural make-up were researched from that first photograph and the spacing, height and angle of the two wood beams and counting cobblestone rows on the wall in the picture and then measuring actual heights on the stones of the house. Using high powered magnifying glasses to understand the intricacies of the bits and pieces, the decorations were scaled and dimensioned. In addition, many books on historic porches and, in particular, the work of A.J. Downing, who's *Architecture of Country Houses* has been thought to be the inspiration for the original house and verandah design were thoroughly researched. And then, finally, working with structural tables, the building code and modern construction practices to determine how to make it look exactly as it did but still be held up by acceptable current means and methods. The attached permit documents explain the nature of all of these details.

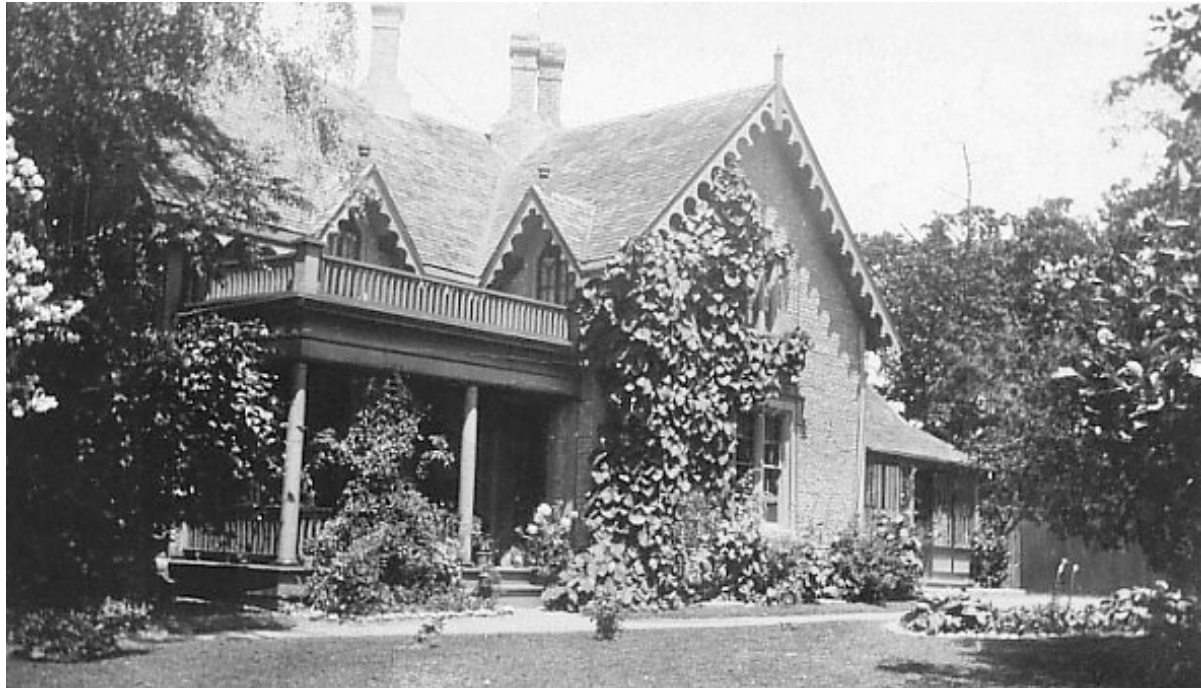
At some point after the turn of the century, and likely some time after the Patton family had sold the house about 1904, the original verandah was removed and replaced with a more 'modern' (classically) designed structure. The closest we can speculate is that this may have been in the 1920's. At any rate, it would have been sufficient time for the original structure to have weathered to a point where it was too deteriorated to repair, or it had simply become un-fashionable. Regardless, the earliest photos we have in our possession are from the Brown family who lived at Kilton Cottage from 1917 to 1943. An undated photo of the verandah from the Brown family shows the very different design from that period.

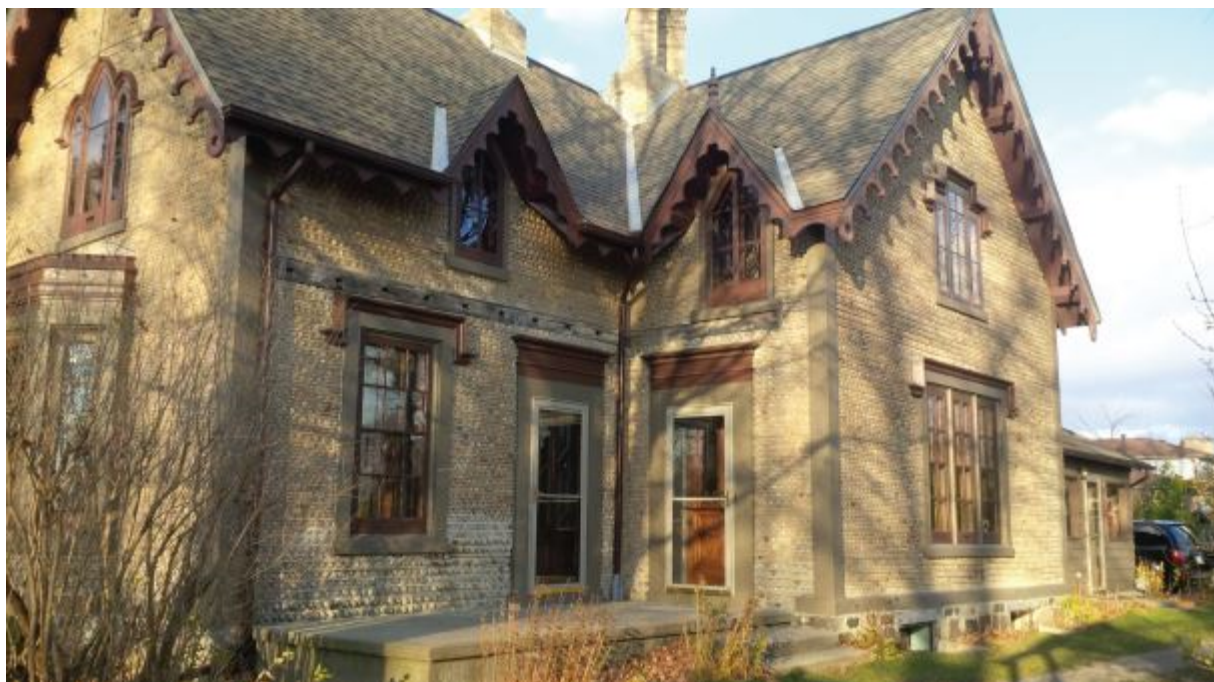
This latter verandah design existed until the mid-1990's at which time it had started to deteriorate severely. While Chair of the Paris Heritage (LACAC) Committee at the time I applied for a permit to demolish the structure, knowing it was not the original verandah and fully intending to recreate the original design. During the dismantling process the construction of the structure was studied and recorded in hopes that parts of it may have incorporated the original design. However, it was clear that this was not the case and the only remaining elements of the original were two wood beams recessed into the stone walls of the house.
